Subject

Premature Wear of the MSL Wheels

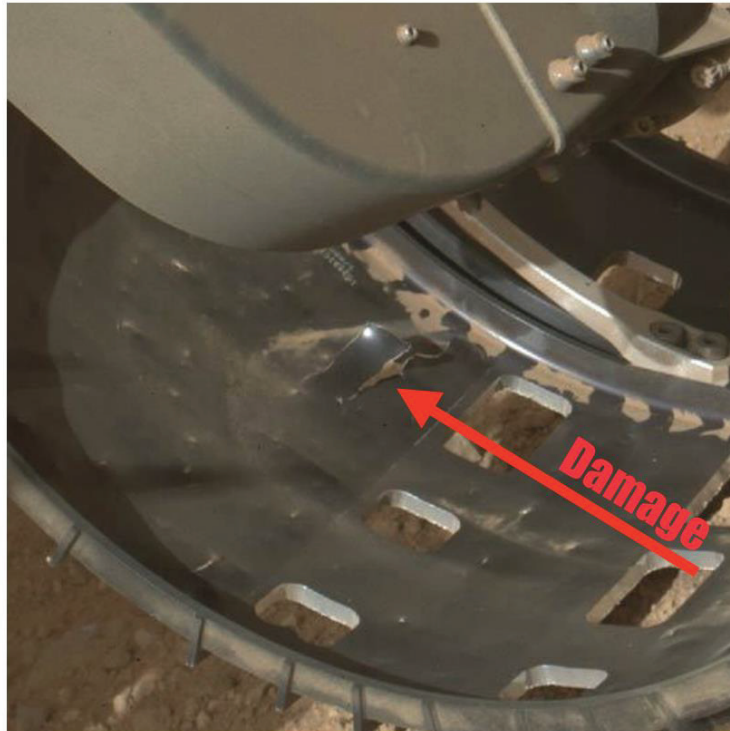
As the rover drives across the surface of Mars, the rover operations team at the NASA/Caltech Jet Propulsion Laboratory (JPL) employs the Mars Hand Lens Imager (MAHLI) camera on the rover's robotic arm to check the condition of the wheels at routine intervals. On sol 411 (October 2, 2013) imagery revealed a puncture in the skin of the left front wheel (Figure 2). This did not raise a concern because such wear and tear was expected, especially in the thinnest areas of the wheel skin between the chevron-shaped grousers (treads). (Previous Mars rover wheels had straight skin protrusions; the chevron feature was provided for the purpose of preventing sideways slip.) However, subsequent visual wheel inspections revealed higher than expected wheel wear, which prompted JPL to start tracking the progression of wheel damage.

Figure 2. Detail view of the inner surface of Curiosity's left front wheel on sol 411. Arrow points to tear.

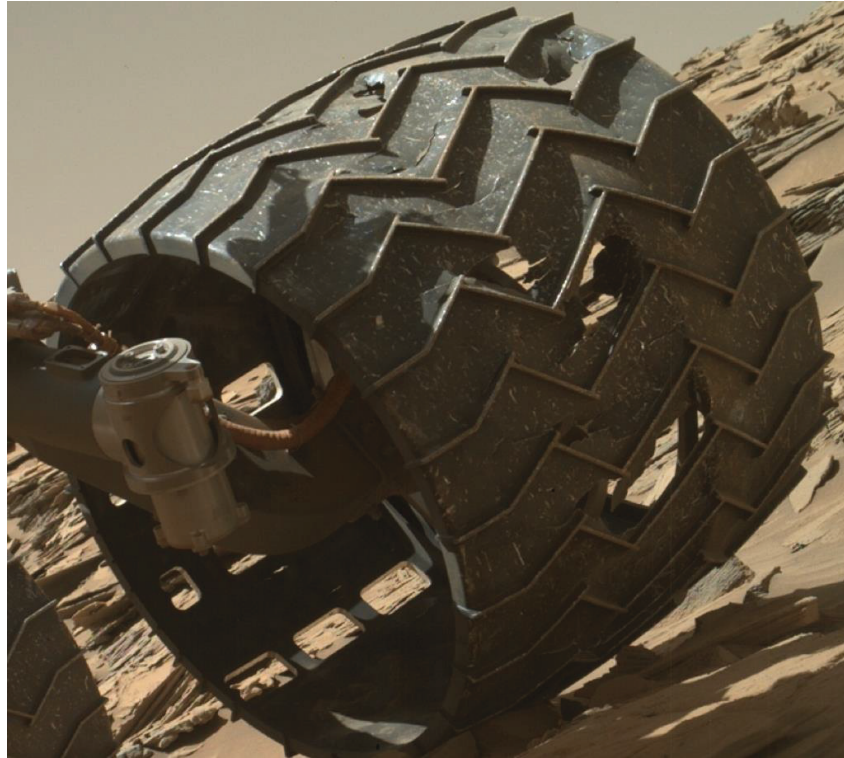
Within a few months of the sol 411 anomaly, the MSL project became concerned by the apparent increase in the rate of wheel damage (Reference (2)), and a tiger team was formed to analyze the problem. By sol 463 (November 24, 2013), a large rip had opened above the Morse-code holes in the left front wheel that was much larger than expected and exceeded any damage seen in testing. The progressive damage to MSL wheels has continued (Figure 3). This rip, and the others that would follow is attributed to single-event punctures, as well as metal fatigue, due partially to the prevalence of ventifacts embedded in bedrock (i.e., immobile, wind-eroded pyramidal rocks). This terrain had not been simulated in pre-launch testing of the wheel (Reference (3), Sec. 4.18) because only limited knowledge about the terrain was available. The stresses from deformation and the metal fatigue are highest on the skin near the tips of the chevron features, and many tears seem to propagate from the chevron tips.

Figure 3. MAHLI full-wheel imagery of Curiosity's left-middle wheel taken on April 18,2016 (sol 1,315)

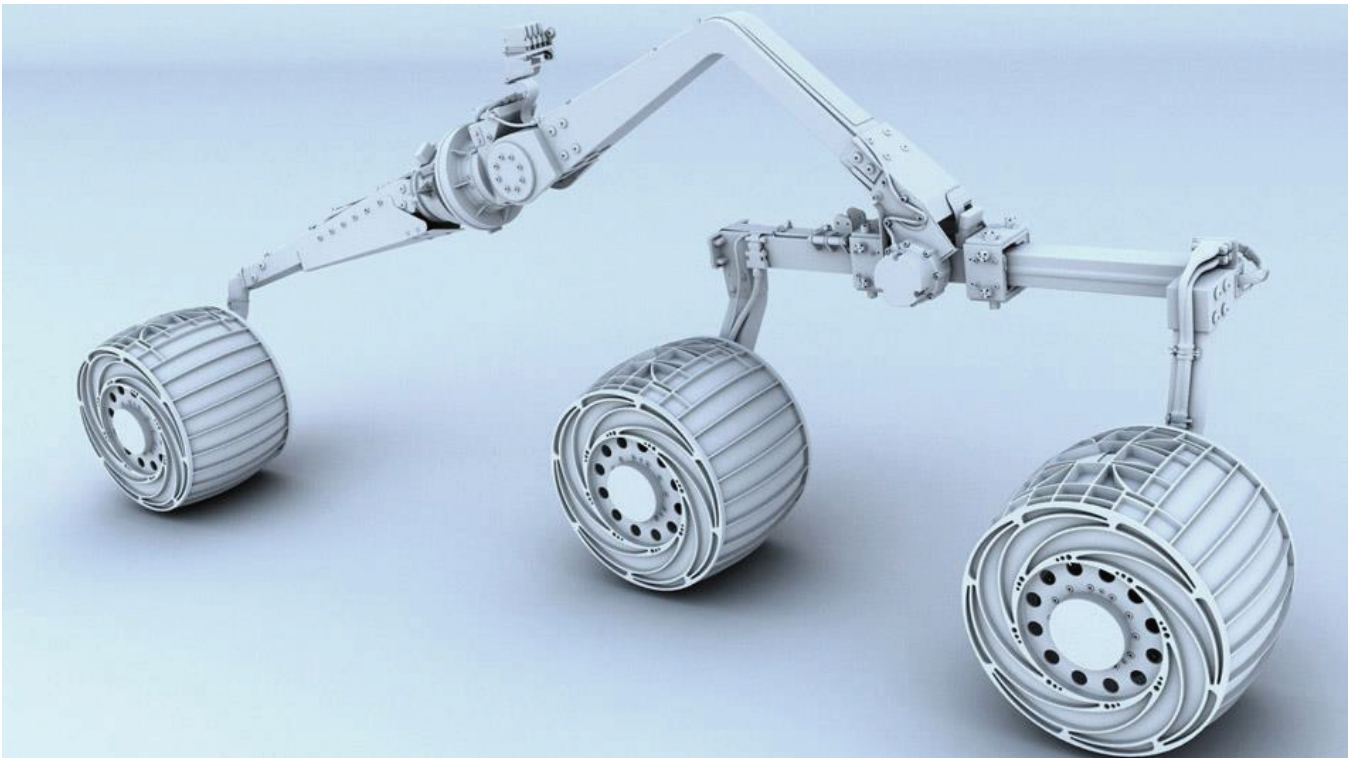
The impact of ventifacts is exacerbated by a dynamic mechanical load on the wheels. The design of the rocker-bogie system (Figure 4) includes wheels that all rotate at the same speed and downward-angled arms that support the middle and front wheels. If a front or middle wheel hangs up on a rock and the rest of the rover keeps driving, the arm exerts a [downward force on the wheel](#). This increases wheel loading well beyond the static weight of the vehicle, and it is sufficient to cause local grouser yielding and skin puncture. The MSL rear wheels, which have experienced minimal damage, do not see this downward force because they are merely dragged behind the arm like a trailer on a hitch. Where this pushing force might have been expected to merely shift a loose pointy rock, [subsequent testing](#) has shown that the punctures are primarily due to the prevalence of pointy rocks that are immobile—either cemented into the ground or a part of the bedrock.[1]

Figure 4. The rocker-bogie mobility system (the wheels depicted are not the Curiosity design) surmounts the face of a vertical obstacle (rock) by having the center and rear wheels force the front wheels against the obstacle. The rotation of the front wheel then lifts the vehicle up and over the obstacle. The rear wheel then presses the middle wheel against the obstacle and the front wheel pulls it against the obstacle until the middle wheel is lifted up and over. Finally, the rear wheel is pulled over the obstacle by the front two wheels.
