Subject

Premature Wear of the MSL Wheels

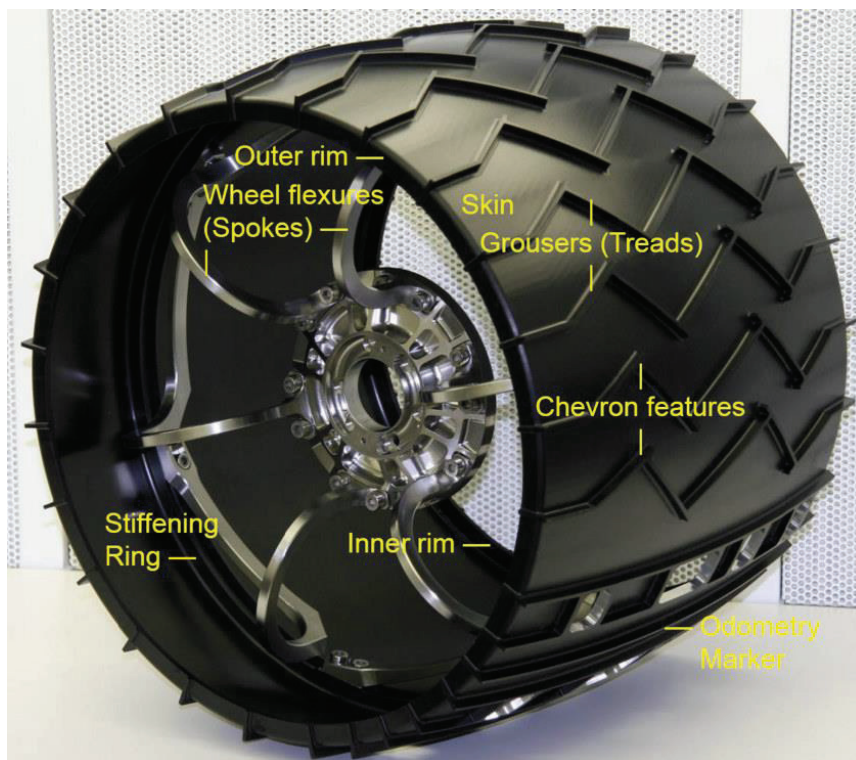
Figure 1. Components of a Curiosity wheel

4. Skin loss around a grouser (whether from fatigue cracks or puncture) causes a change in the wheel load path, loading said grouser beyond the material yield limit. This material overload situation will eventually cause all wheel grousers to fail, generally at the location where the grousers meet the wheel internal stiffening ring (Figure 1).
